**Case Report**

# Magnet Removal and Reinsertion in a Cochlear Implant Recipient Undergoing Brain MRI

Lela Migirov Michael Wolf

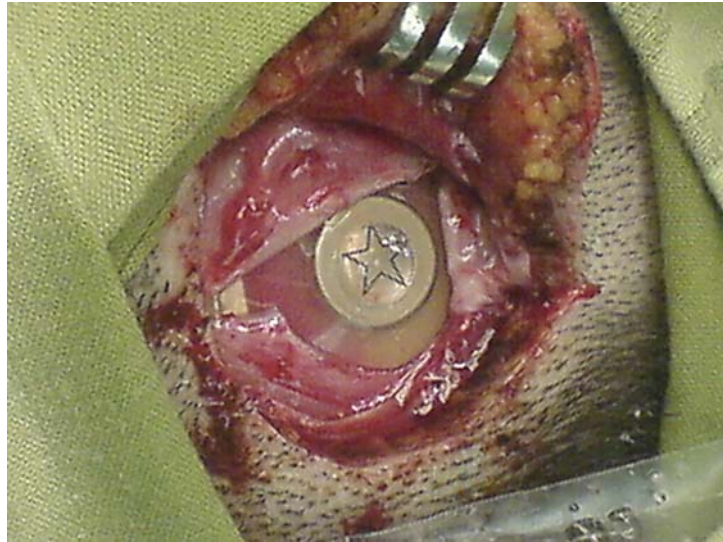
**Fig. 1.** Elevation of the flap and incision of the capsule over the implant.

A 33-year-old female with bilateral progressive profound sensorineural hearing loss of unknown origin received a Freedom Contour Nucleus (Cochlear LTD, Sydney, N.S.W., Australia) device in the year 2000. The device provided her with good hearing in the fitted ear. Eight years after her CI, she developed polyneuropathy associated with persistent headache and extreme muscle weakness that required performing an MRI. After the administration of local anesthesia, the magnet was removed by a surgical incision made along the posterior margin of the receiver-stimulator. Care was taken not to perform the incision over the site of magnet, as doing so could interfere with the wearing of the device thereafter. The flap was elevated and the capsule over the implant was incised (fig. 1). The magnet was removed (fig. 2) and maintained under sterile conditions, and the wound was closed with 3 temporary sutures and covered with a sterile pad. The magnet was reinserted immediately after the completion of the 1.5-Tesla MRI, and the wound was closed in two layers (fig. 3). Both the removal and replacement procedures were performed by an experienced CI surgeon (L.M.). The patient was able to wear her device immediately after surgery. A small sterile pad was used to separate the incised skin from the external coil of the device during the first week following surgery. The postoperative course was uneventful. The MRI failed to demonstrate any findings that could explain the patient's neurological condition. Large CI-associated artifacts were observed on the MRIs irrespective of the performed sequences (fig. 4, 5). The function of the device was not altered by the MRI nor by the surgical procedure and the patient is still using her device.

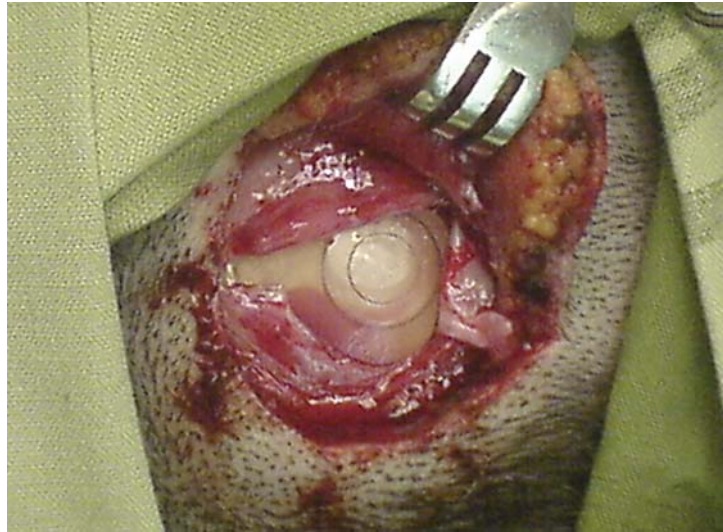
**Fig. 2.** The magnet has been removed.

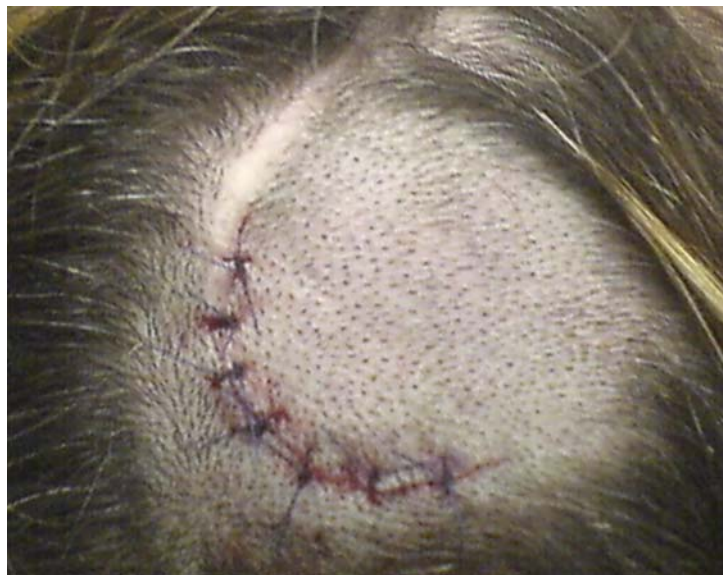
**Fig. 3.** A closed wound after reinsertion of the magnet.

The internal magnet of a CI can be removed and reinserted under local anesthesia, at least in adult recipients. The proposed surgical incision that follows the posterior margins of the receiver-stimulator allows the wearing of the device immediately after the surgical procedure. An MRI has limited diagnostic value for lesions located on the implanted side due to unavoidable artifacts, even after the magnet has been removed.

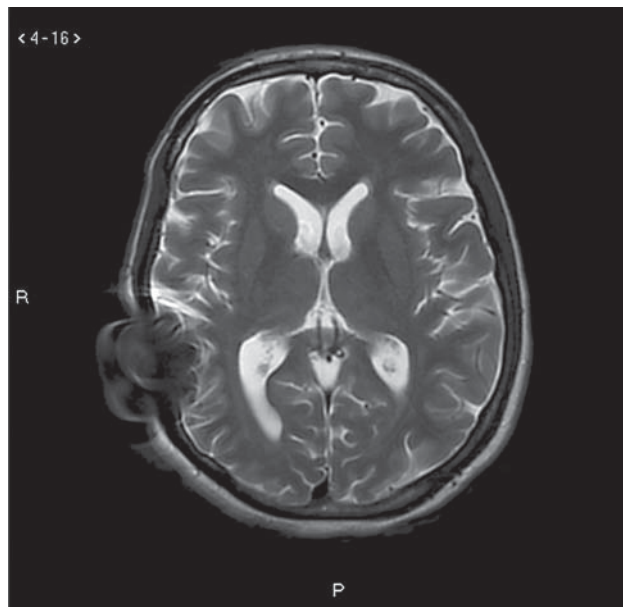
**Fig. 4.** An axial T2 Flair MRI showing an artifact ipsilateral to the implant side.

The issue of surgical removal of the internal magnet prior to MRI in CI patients remains controversial. On the one hand, there are large artifacts on the MRI when the magnet is not removed and only a bandage is used during the imaging studies [3]. Crane et al. [3] found that the CI generally produced an artifact on brain MRIs, with a mean maximal anterior-posterior dimension of 6.6 cm and a lateral dimension of 4.8 cm around the site of the device. They reported that the contralateral internal auditory canal was visualized in all of their 16 patients, and that the ipsilateral internal auditory canal was at least partly visible in all but 1 patient. On the other hand, a surgical procedure for the removal and consequent reinsertion of a magnet can be associated with a risk of local infection at the implant site or even displacement of the magnet when another MRI is performed [4]. Specifically, a failed MRI may require the performance of additional images, this time with the removal of the magnet, and this manipulation can result in CI malfunction. Patients should be informed about the possibility of implant malfunctioning, infection following surgical procedure, magnet displacement during the MRI and reversal of the polarity of the magnet after an MRI [4, 5]. Note that magnet removal is not applicable in implants with ceramic housing, in old models of the Nucleus device with irremovable magnets and in current devices with titanium housing, e.g. from the

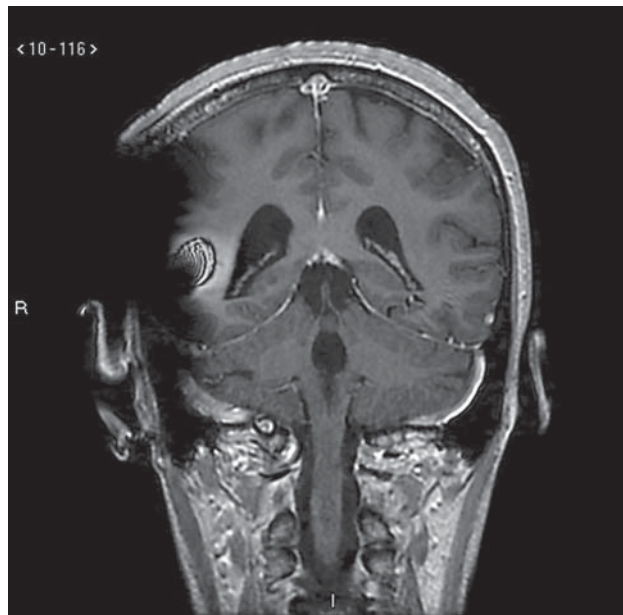
**Fig. 5.** A coronal 3-dimensional TOF MRI showing a large artifact ipsilateral to the implant side.
