Case Report

Magnet Removal and Reinsertion in a Cochlear Implant Recipient Undergoing Brain MRI

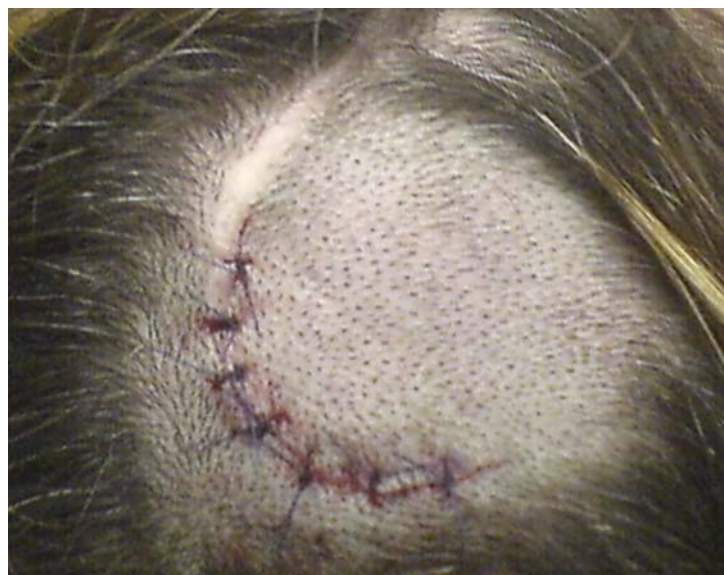
Fig. 3. A closed wound after reinsertion of the magnet.

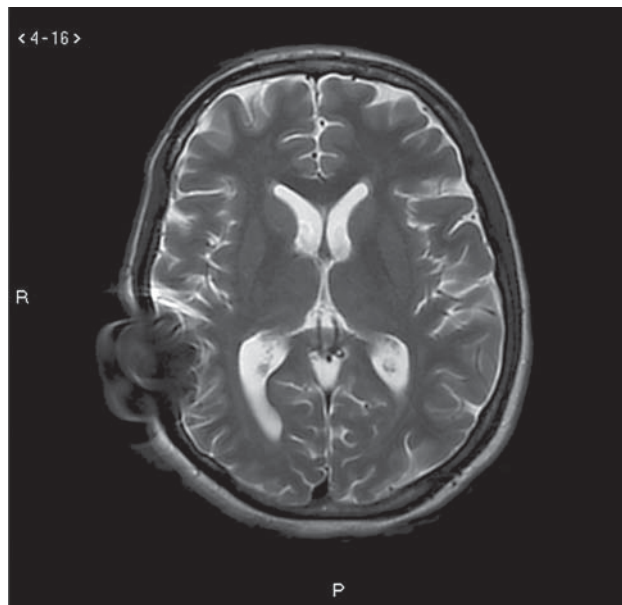
Fig. 4. An axial T2 Flair MRI showing an artifact ipsilateral to the implant side.

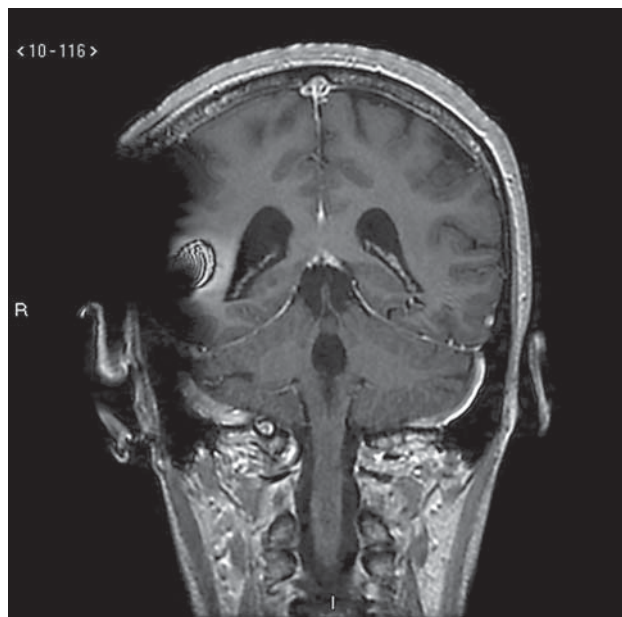
Fig. 5. A coronal 3-dimensional TOF MRI showing a large artifact ipsilateral to the implant side.
